FINAL ENGINEERING REPORT

TIROS II

METEOROLOGICAL SATELLITE SYSTEM

VOLUME II

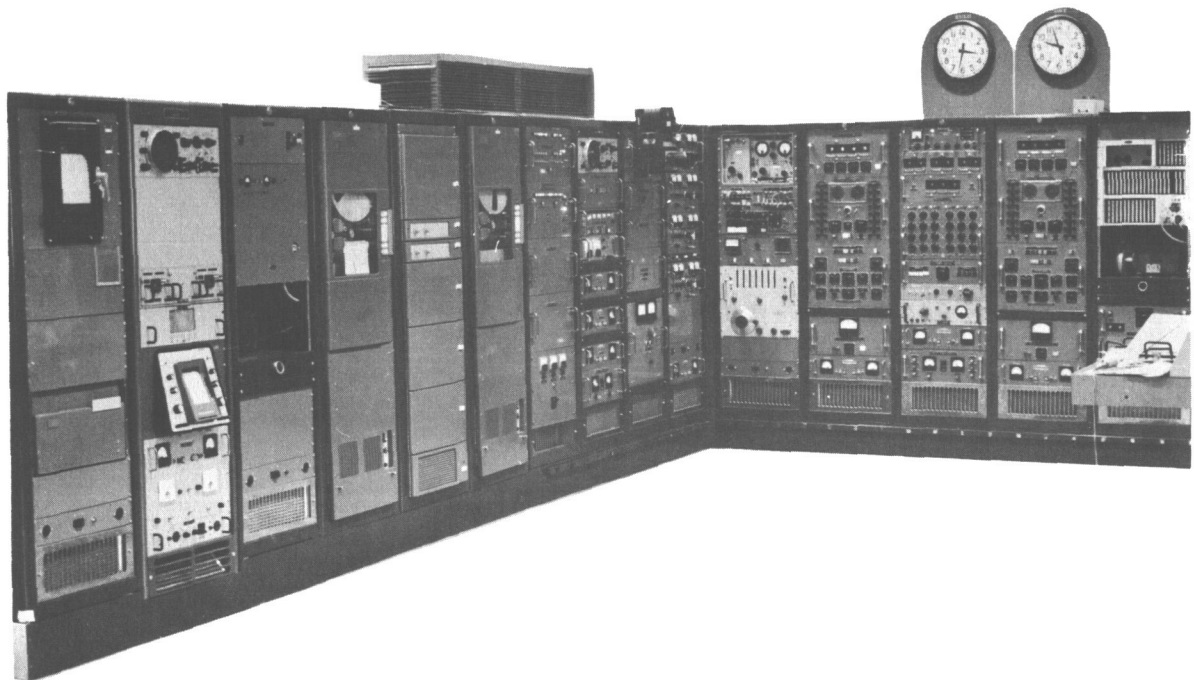
Figure 84. Fort Monmouth Ground Station

A change was also made in the operating personnel for the station. Although the Signal Corps maintained the operating responsibility for the tracking station and the maintenance responsibility for the tracking antenna, station operating personnel were all from the RCA Service Company. Engineering support was supplied by RCA-AED. The equipment racks of the Fort Monmouth ground station are shown in Figure 84.
